# Modes of decay

In almost every instance, the cause of decay is likely to be a combination of several of the factors listed in the table. The more prevalent types of decay and their various causes are as follows.

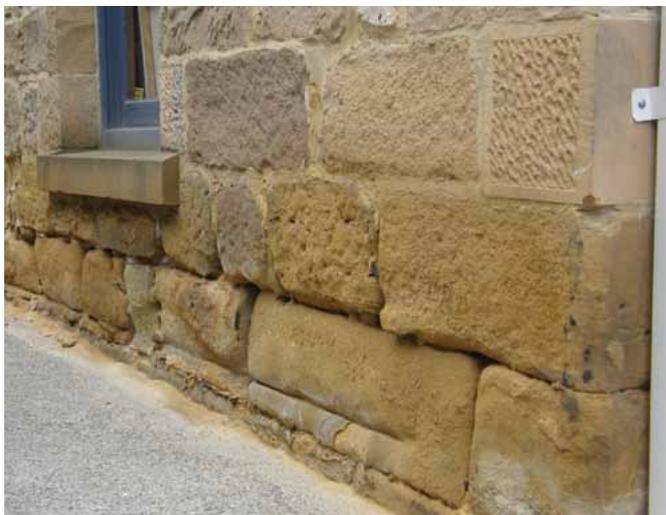
**Figure 1.** Disaggregation of external ashlar in the lower courses of a Hobart building. (Photo: Jasper Swann, 2008)

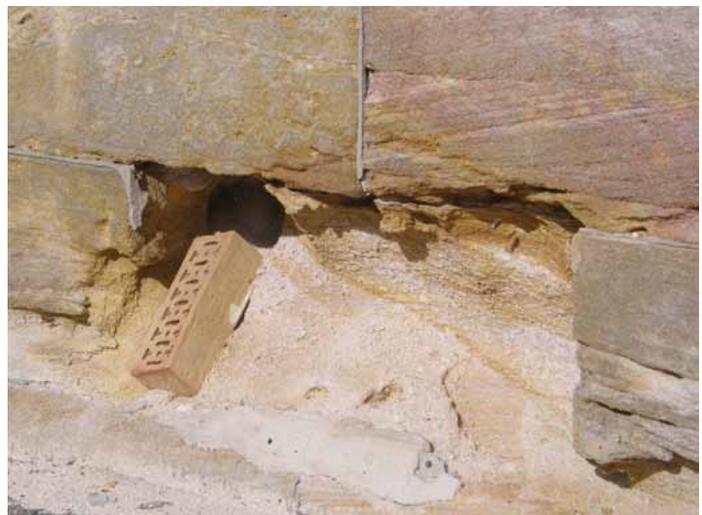
**Figure 2.** Severe disaggregation caused by salt damp, Spectacle Island, Sydney Harbour. Note the collapse of the vent formerly located in the wall. (Photo: Jasper Swann, 2007)

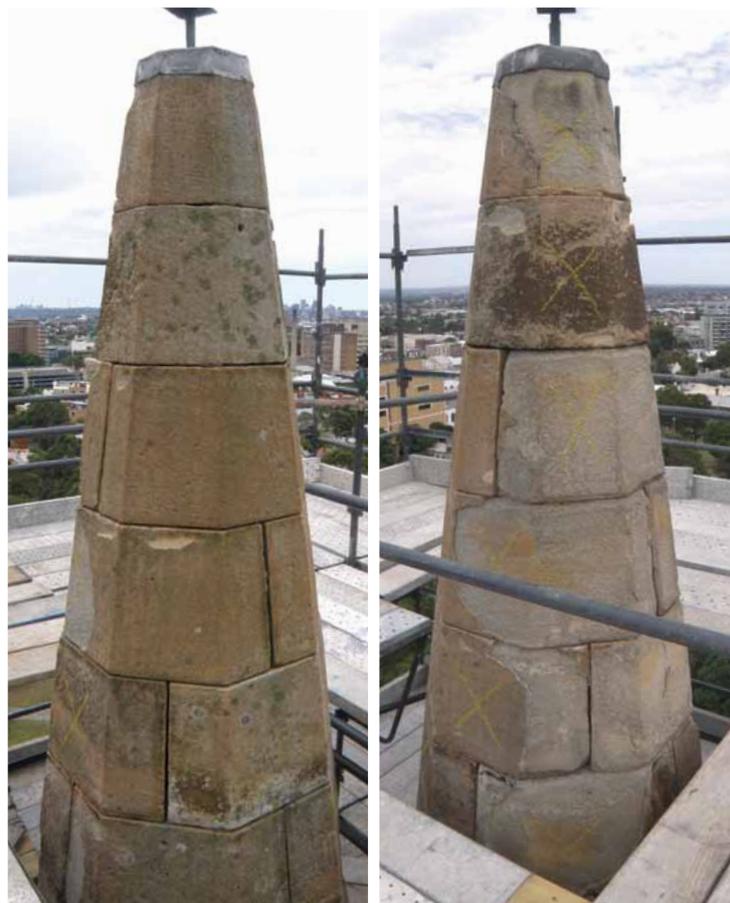
**Figure 6.** The southwest (left) and northeast faces of a Sydney church spire, showing sheet exfoliation of the faces exposed to the sun. (Photo: Jasper Swann, 2010)

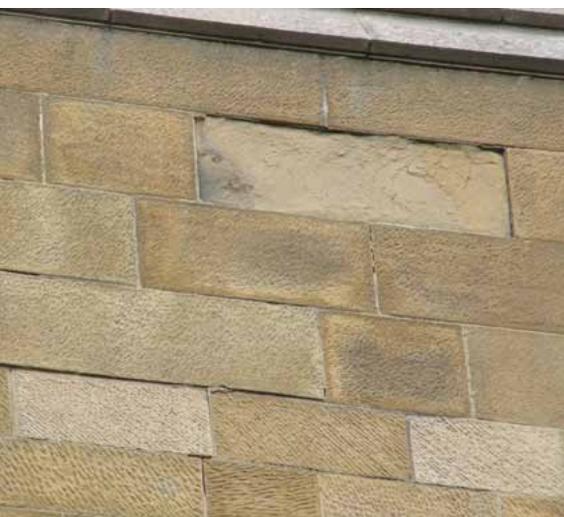
**Figure 3.** Delamination of face-bedded ashlar, St David's Cathedral, Hobart. (Photo: Jasper Swann, 2008)

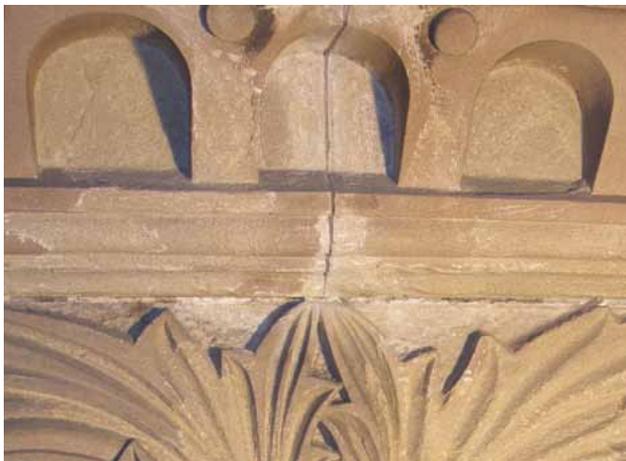
**Figure 7.** Contour-delamination in the cornice mouldings and carved frieze below, Queen Victoria Building, Sydney, caused by deposition of salts, (visible), beneath case-hardened layer. (Photo: Jasper Swann, 2008)

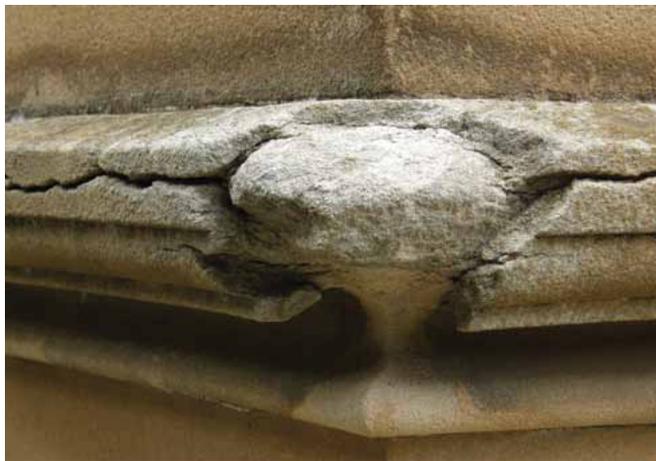
**Figure 8.** Contour delamination of a Sydney yellowblock string course, Mitchell Building, University of Adelaide. (Photo: Jasper Swann, 2009)

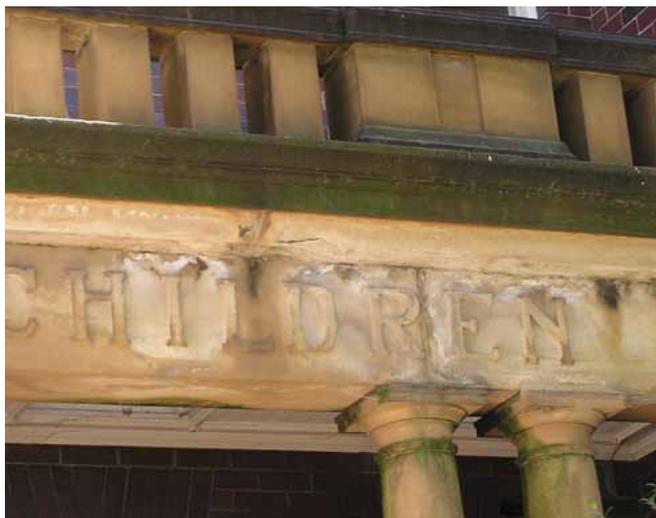
**Figure 10.** Efflorescence below the balcony of the former Children's Hospital, Camperdown, NSW. (Photo: Jasper Swann, 2006).

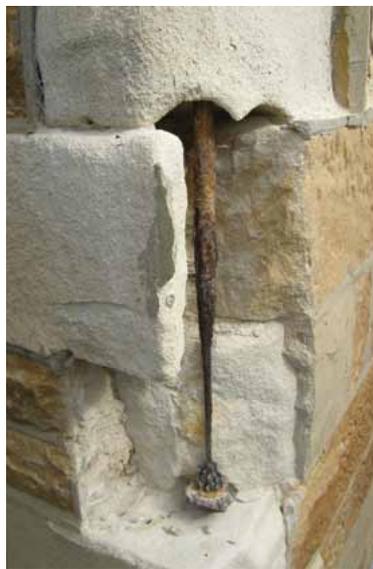
**Figure 12.** A rusted iron fixing, originally anchoring the spire, has destroyed the quoins on this church tower in Kiama, NSW. (Photo: Jasper Swann, 2009)

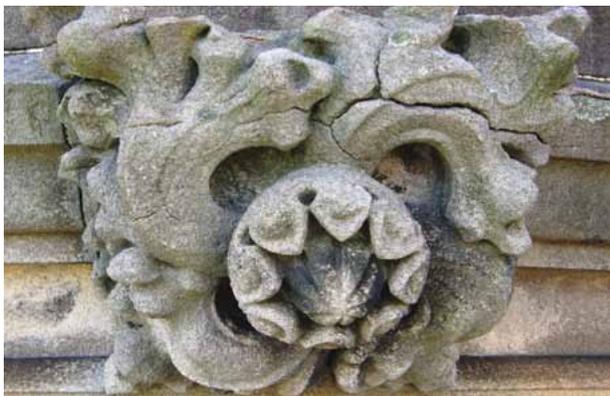
**Figure 13.** Cracking of a carved boss in Sydney yellowblock. (Photo: Jasper Swann 2008)

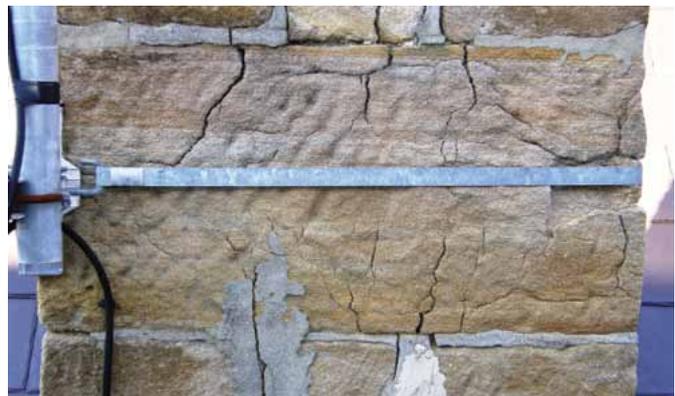
**Figure 14.** Cracking in a chimney shaft. (Photo: Jasper Swann, 2007)

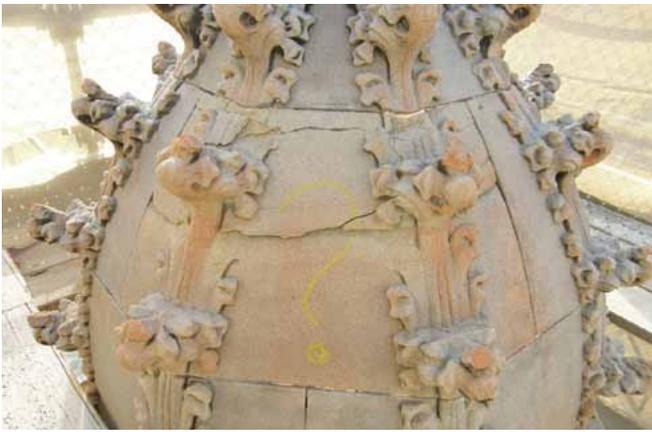
**Figure 15.** Cracking along a natural plane of weakness. In this instance, the carved stone has sheared through its width completely, and being under little compression, it is at the point where the upper portion of the stone can be dislodged by hand. (Photo: Jasper Swann, 2008).

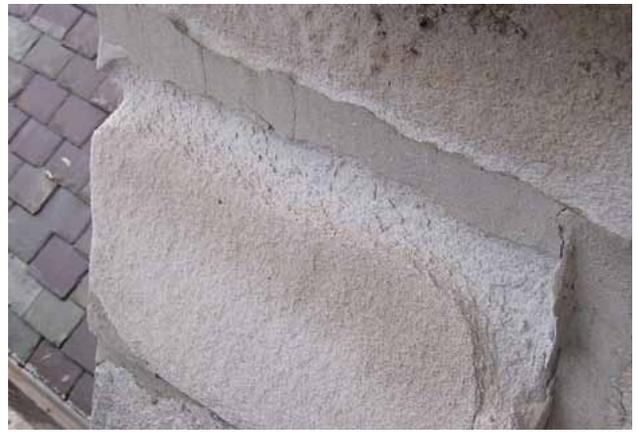
**Figure 16.** Preferential decay of a buttress stone as a direct result of the unsuitable grey cement mortar used to repoint its upper bed joint. Hunter Baillie Memorial Church, Annandale, NSW. (Photo: Jasper Swann, 2007).

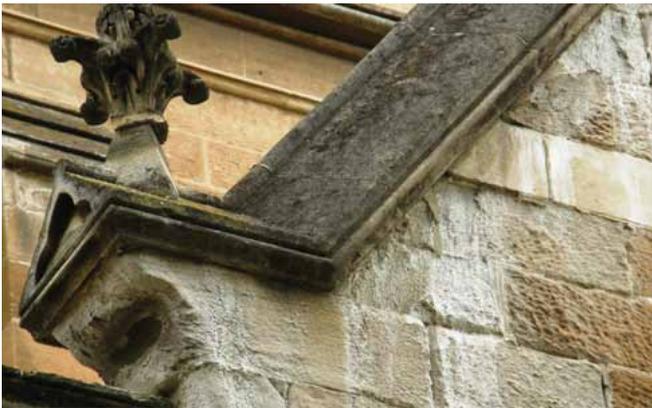
**Figure 17.** Preferential erosion of sandstone beneath a limestone coping, Elder Hall, University of Adelaide. Note the almost perfect condition of the limestone copings. (Photo: Jasper Swann, 2009)

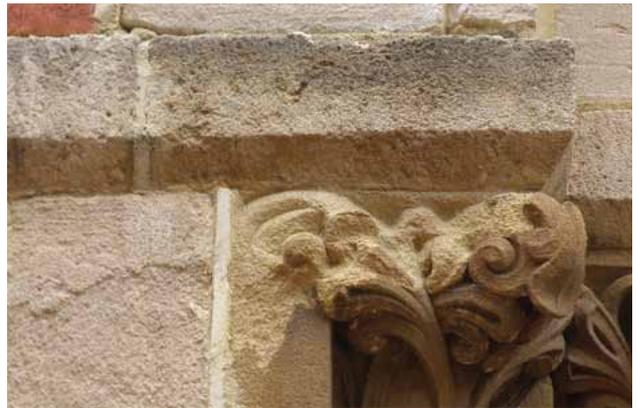
**Figure 18.** Decay of carved yellowblock sandstone capital due to gypsum run-off from limestone string course and voussoirs immediately above. St George's Cathedral, Perth. (Photo: Jasper Swann, 2009)

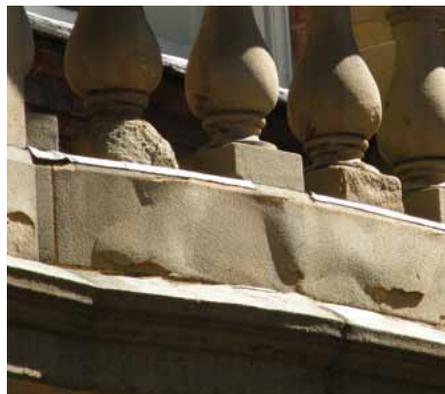
**Figure 19.** Severe blistering of Sydney Yellowblock, Newcastle, NSW. (Photo: Jasper Swann, 2009)
