## St Mary's Cathedral — Conserving a Sydney Icon

*Stonework Consultant and Client's Project Manager, Jasper Swann, reports on the current program of stonework conservation at St Mary's Cathedral. The works, funded by the Catholic Archdiocese of Sydney, have been documented by TKD Architects and are being undertaken by HBS Group.*

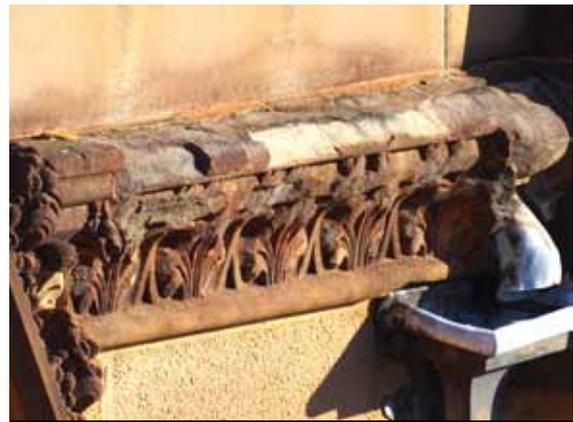
*Figure 2. Deterioration of carved cornice cornices in the clerestory.*

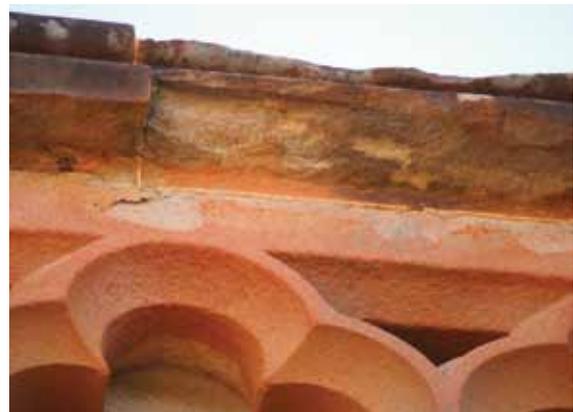
*Figure 3. Failure of parapet copings leading to decay of the stonework below.*

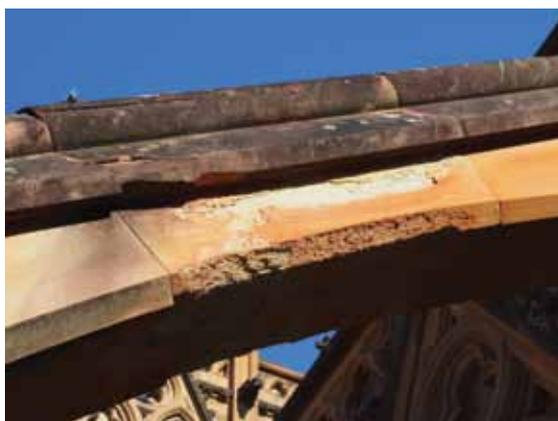
Figure 5. Advanced deterioration necessitates replacement of this stone in a flying buttress.

Of the six flying buttresses in the northeastern portion of the Cathedral, one possesses a stone at its centre that has deteriorated to the point of potentially compromising the structural integrity of the buttress in the foreseeable future. (Figure 5 & 6). Replacement of this stone is required to ensure its long-term stability. The remaining buttresses all need works – indents, desalination, mortar repairs, repointing – but nothing that requires their deconstruction.

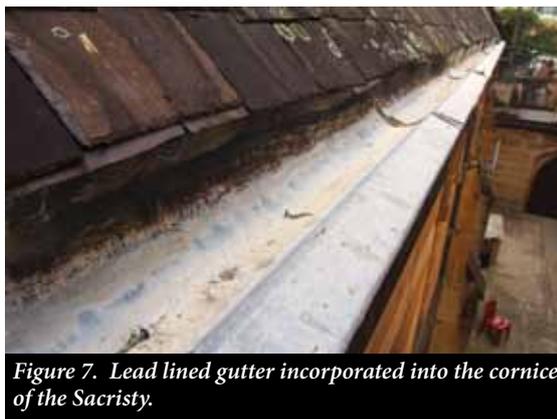
*Figure 7. Lead lined gutter incorporated into the cornice of the Sacristy.*

Hollowed into the top bed of the cornice, the gutter drains along gentle falls to downpipes that pass through a series of carved bosses engaged in the cornice, (Figure 7 & 8). The gutter is lined with lead. On the face of it, it is a neat design that effectively hides the gutter from view when observed from the ground. In practice however, the detail in the Sacristy, (and elsewhere), has failed to consistently and effectively drain rainwater collecting in it. One of its weaknesses is its restricted fall between downpipes. Being worked into

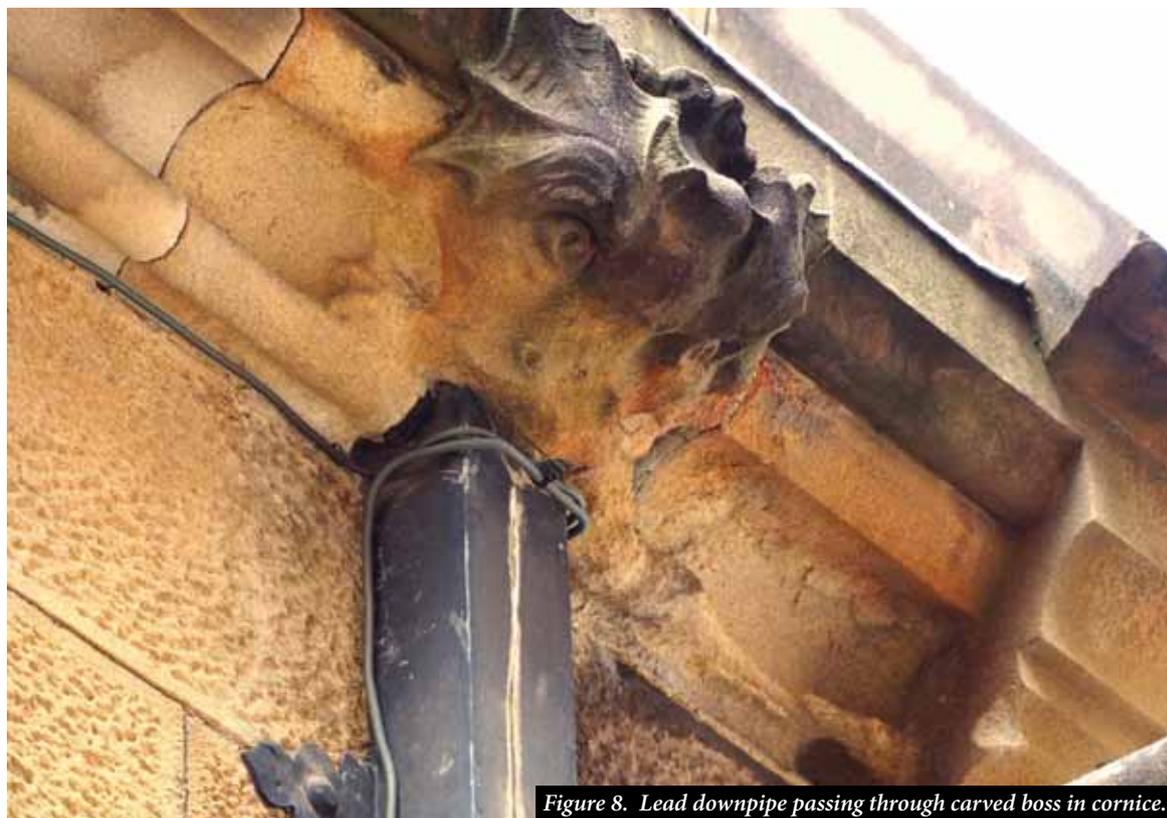
*Figure 8. Lead downpipe passing through carved boss in cornice.*

the cornice, there is insufficient material to allow the introduction of more than a single step in the gutter in each long run. Overspill occurs during periods of heavy rain and penetration of water through the welted joints in the lead lining has caused deterioration of the carved bosses, the cornice itself and, in places where decay has gone unchecked, the stonework below. In addition, continuous long lengths of lead between downpipes, in the absence of steps, have cracked in response to diurnal forces of expansion and contraction. This has allowed further water penetration and deterioration of the cornice and the stonework below.

The replacement of some of the worst-affected cornice stones was considered necessary to preserve the architectural integrity of the building. But to do so without rectifying the cause of their failure would not have been prudent. To that end, two design initiatives have been implemented which it is hoped will prevent recurrence of the historically common failure of this particular gutter detail.

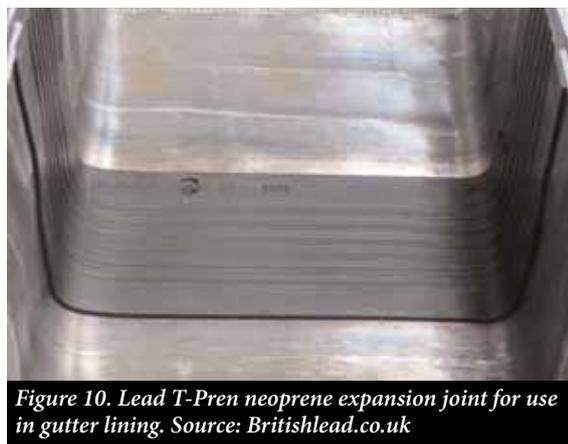
Figure 10. Lead T-Pren neoprene expansion joint for use in gutter lining. Source: Britishlead.co.uk

In the second, to prevent seepage of water through joints in the lead lining, and to simultaneously overcome the potential for cracking of the lead in response to its expansion and contraction, Lead T-Pren neoprene joints will be installed in place of the traditional welted joints, (Figure 10). The neoprene rubber expansion insert is factory-bonded to the lead either side of it by a process of vulcanization. These joints offer a practical solution where restricted falls and existing architectural details prevent the introduction of stepped joints. Designed to perform in temperatures up to 100 degrees Celsius, and resistant to the effects of UV light, they are suitable for use in Australia. Nonetheless, as a 'belt-and-braces' measure, a lead covering will be installed over the neoprene to protect it from the harsh Australian sunlight. Introducing a welded seam at one end only will secure this additional protective cover adequately whilst still allowing it to move freely in tandem with the neoprene.
