# SYDNEY YELLOWBLOCK IS ITS REVIVAL A BLESSING OR A CURSE?

JASPER SWANN investigates how the recent stockpiling of yellowblock sandstone is causing a collision between principles and practice in the conservation of Sydney's prominent sandstone buildings, and explores some alternative approaches.

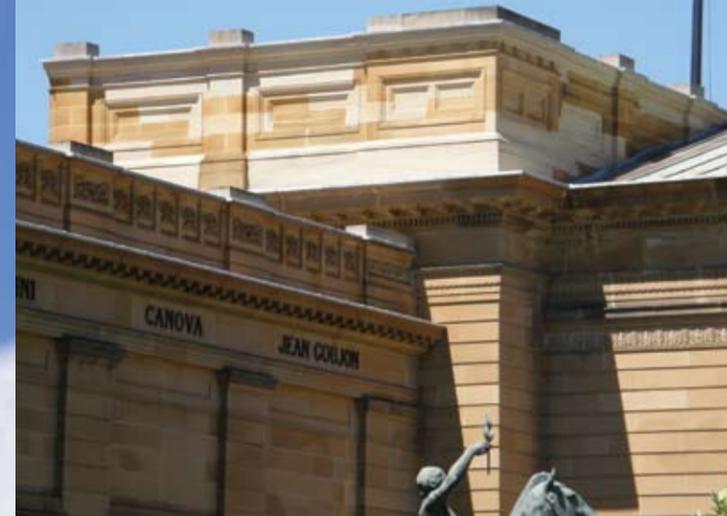
Photo 1: Art Gallery of New South Wales, restored using Capricorn Custom Buff. Photo 2: Darlinghurst Law Courts, Sydney. Photo 3: Replacement of the cornice and balustrade at the Australian Museum. (Photos: Jasper Swann, 2007)

A subsequent dalliance with a Queensland stone, Capricorn Custom Buff, for a number of significant buildings, such as the Art Gallery of New South Wales and Sydney University Quadrangle Building, produced outcomes that couldn't really be said to be satisfactory. The Custom Buff may have been a good quality stone, and it may have been a perfect match for the nineteenth-century buildings of Rockhampton and certain colour-stable stones around Australia, but it was far from being a suitable match for Sydney yellowblock, as inspection of either of those buildings will reveal.

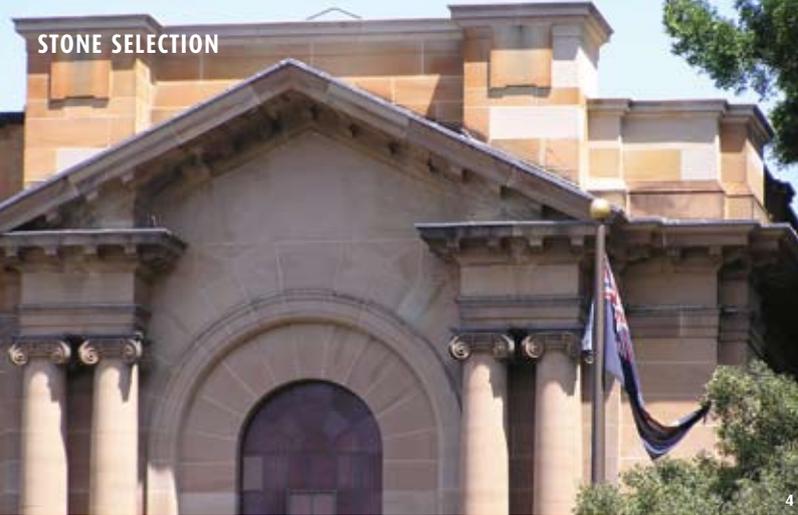
**Photo 4: Replacement stone in the parapet at the State Library of NSW. Photo 5: Wholesale replacement of stone in the pediments, tower and balustrades of Sydney Observatory. Photo 6: McCaffrey's stone in the Anderson Stuart Building, University of Sydney. (Photos: Jasper Swann, 2007)**

Replacement of small quantities of stone can also be disfiguring. New stones introduced at the State Library of NSW and the Anderson Stuart Building at the University of Sydney are conspicuous in their stark unsuitability.

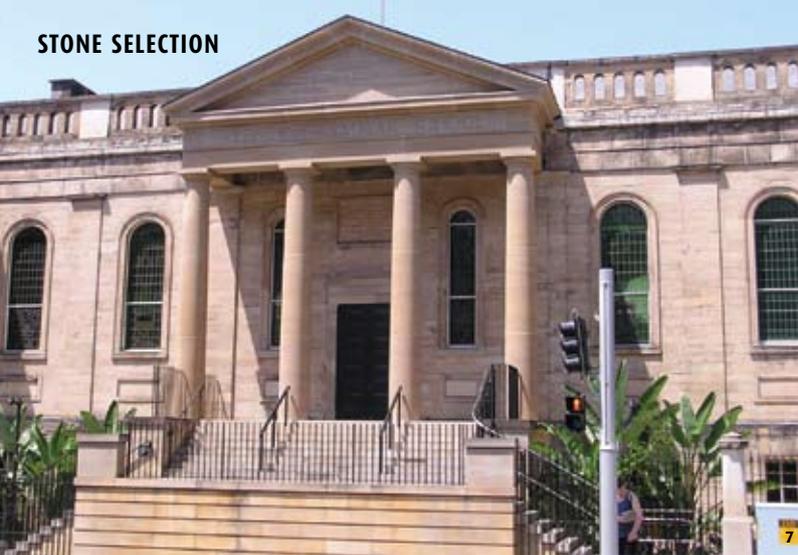
Photo 7: Guinea Gold stone used for the new portico at Sydney Grammar School. Photo 8: A piece of McCaffrey’s (top) above a piece of Guinea Gold, eight weeks after sawing. Photo 9: Irregular manganese staining on a piece of Guinea Gold and (photo 10) its removal using a weak hydrochloric acid solution. (Photos: Jasper Swann, 2007)

In mid-2007, a piece of Guinea Gold sat alongside a piece of McCaffrey's yellowblock in my yard for several weeks. The two stones were indistinguishable in colour when first off the saw, but after eight weeks, the contrast was striking: the Guinea Gold had taken on its characteristic warm yellowing, whilst the McCaffrey's remained unchanged. But one face of the Guinea Gold developed an irregular brown staining, and this is one of the stone's inherent problems. The Guinea Gold often does not oxidise uniformly. It suffers from irregular concentrations of iron and manganese that can show up on oxidisation as a chocolate-brown and occasionally black discolouration. However, this can be controlled by the application of a weak hydrochloric acid solution, a practice carried out for decades but now actively precluded in almost every stonework specification. Application of the acid wash leads to a complete removal of the staining within a day or two. The effect is permanent and the

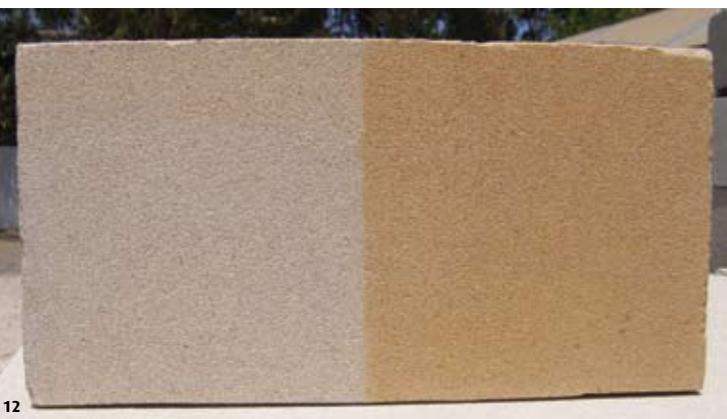
Photo 11: The new spires of St Mary's Cathedral, Sydney – Wondabyne stone.  
Photo 12: A piece of McCaffrey's stone artificially and permanently coloured.  
(Photos: Jasper Swann, 2007)

Simple experiments that I conducted in 2007 have demonstrated that this same colouring solution is just as effective when applied to the McCaffrey’s stone as it is when applied to a recalcitrant piece of Guinea Gold. And it would be hard to argue that the resultant colour of the stone isn’t a better match for Sydney yellowblock.
