The safe removal of asbestos

– containing pointing from masonry facades – a fresh approach

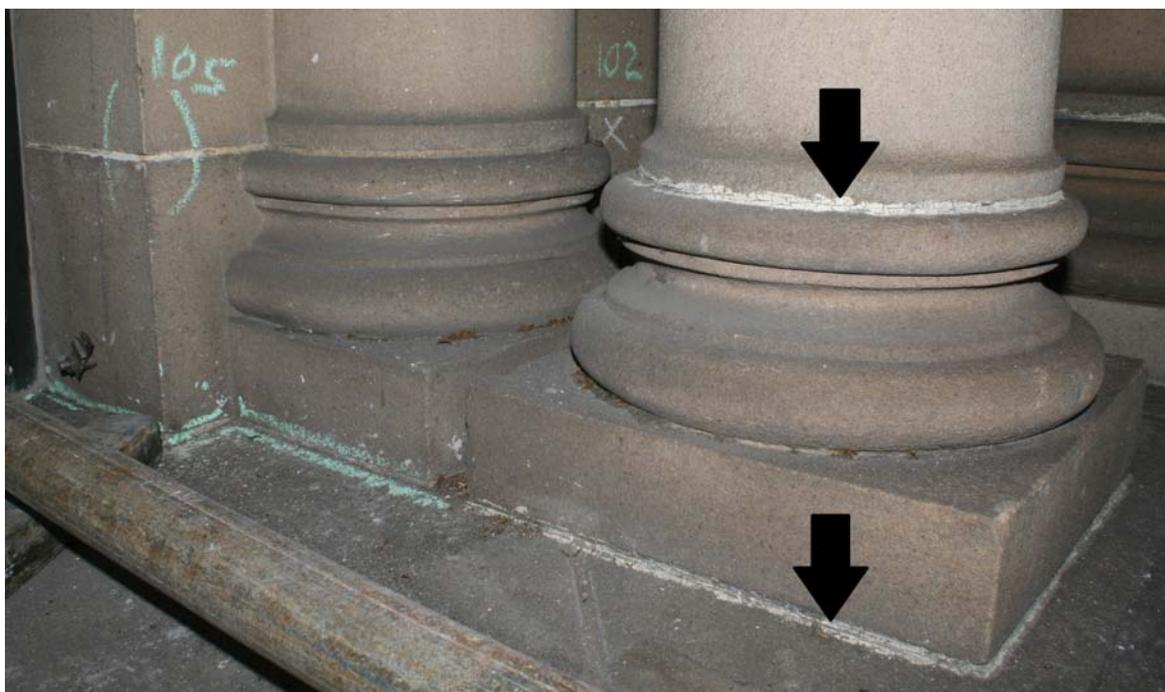
Image 2. Sydney Town Hall: East Facade. The joints indicated by the arrows have been repointed with an off-white putty which laboratory testing showed contained asbestos. The crudeness of its application was one of the dominant visual clues allowing its consistent identification. Laboratory testing showed that the types of pointings evident in all other joints in the image did not contain asbestos. (Image: Peter McKenzie, 4 July 2012)
